**Client Name:** Girls and Boys Town

**Project Description:** Re-Solve was appointed by Girls and Boys Town to assist with reducing their overall water consumption at their Magaliesburg campus, as they had been receiving exorbitant monthly municipal water bills. The campus is over 70 years old, and money had been spent to upgrade the infrastructure, however, frequent leaks and pipe bursts were still a common occurrence. As part of Re-Solve's Corporate Social Responsibility, a discount of R50 000 was provided to Girls and Boys Town on the cost of the work to be undertaken.

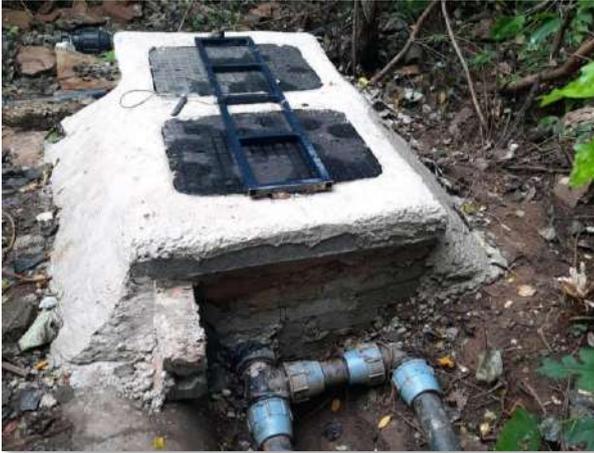
*Newly built PRV chamber*

- Installation of a new Pressure Reducing Valve – Installing a new 50mm diameter pressure reducing valve to reduce the remarkably high pressure at the campus to acceptable pressure levels. An instantaneous pressure test taken at the high/critical point revealed that the pressure was 6.5Bar and this was where

- Installation of a new 50mm Pressure Reducing Valve, water meter, strainer, and isolation valve. The PRV was set to reduce the incoming water pressure from 16Bar to 3Bar.
- Visual leak detection and repairing of leakages identified from toilets, urinals, and taps.
- Installation of a check meter, sub-meters, and a GSM logger to record water consumption for the whole campus and at various locations within the campus.
- Refurbishment of the existing borehole involving the installation of a new borehole pump and motor, a new borehole cover, new electrical cabling, and isolators.

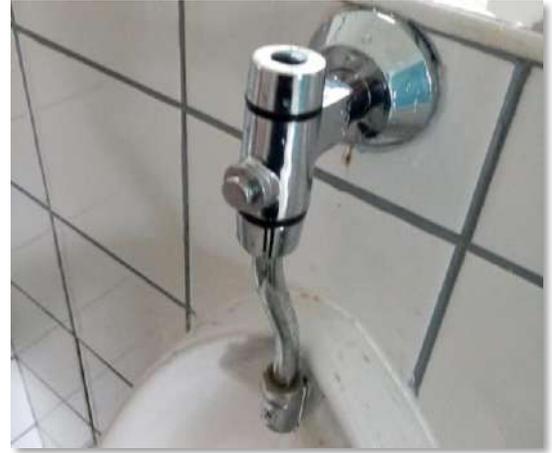
*Repaired urinal*

- **Leak detection and repairing of leaks** – This followed the installation of the PRV to ensure that no further pipe bursts or leaks occur, after the water pressure has been reduced. This phase was completed through visible leak detection and all the leaks found were repaired

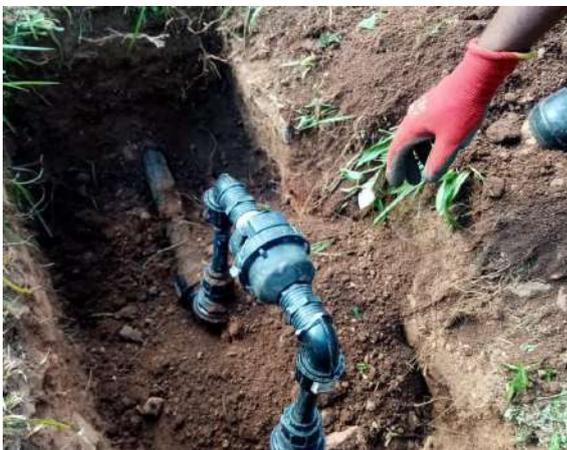
*Newly installed 20mm sub-meter*

In addition to the PRV installed and leakages repaired, 20mm diameter sub-meters were installed at various locations within the campus. These sub-meters assist campus management to accurately track the consumption of each building and ensures that the area supplied by each sub-meter can be isolated. The Re-Solve team installed a check meter and installed a real-time GSM logger on the meter. The GSM logger transmits water consumption data to a cloud-based platform where it can be stored and accessed remotely. The refurbishment of the water treatment plant was not included in the final approved scope

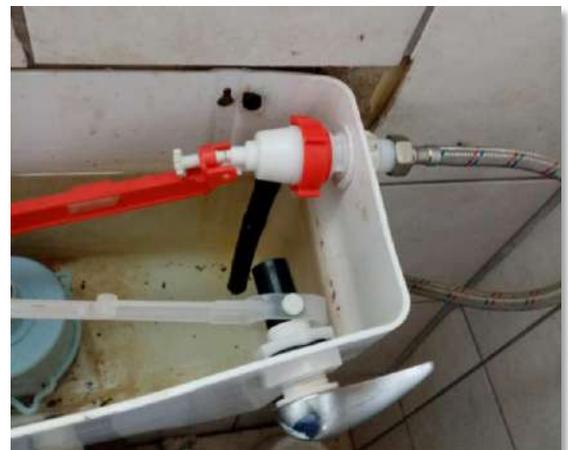
*Repaired Toilet cistern*
